Flight Service Evaluation of
Kevlar-49 Epoxy Composite
Panels in Wide-Bodied
Commercial Transport
Aircraft - Fourth Annual
Flight Service Report

LOCKHEED-CALIFORNIA COMPANY
BURBANK, CA 91520

CONTRACT NAS 1-11621

April 1978

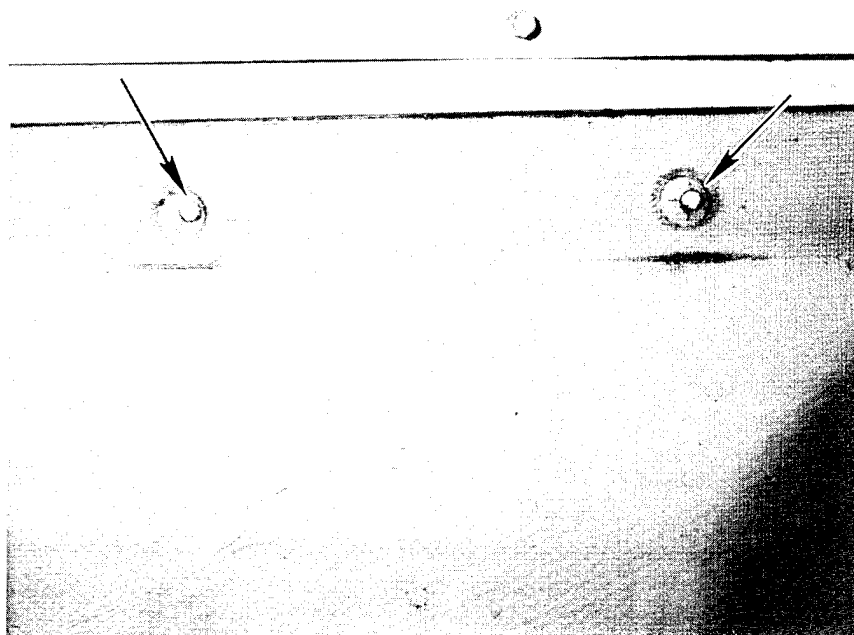
- 5) Slight fraying of the fastener holes was visible from the exterior on all four edges, with more fraying noted on the bottom edge. Heavier fraying was noted on three holes, one on the top edge and two on the aft edge. (Figure 12)

Figure 12. Eastern LH Wing-Body Fairing - Frayed Fastener Holes, Lower Aft Edge on Inner Surface

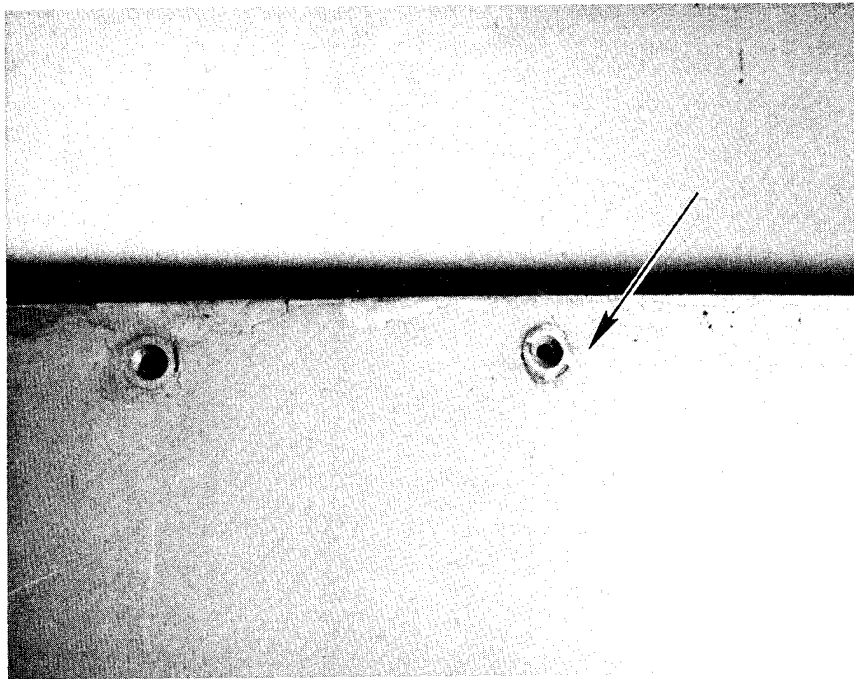
- 7) Considerable paint chipping and re-painting was noted around the fastener holes. (Figure 13)
- 8) No evidence of Skydrol contamination.

Figure 13. Eastern LH Wing-Body Fairing - Paint Loss Areas Around Fastener Holes, Exterior

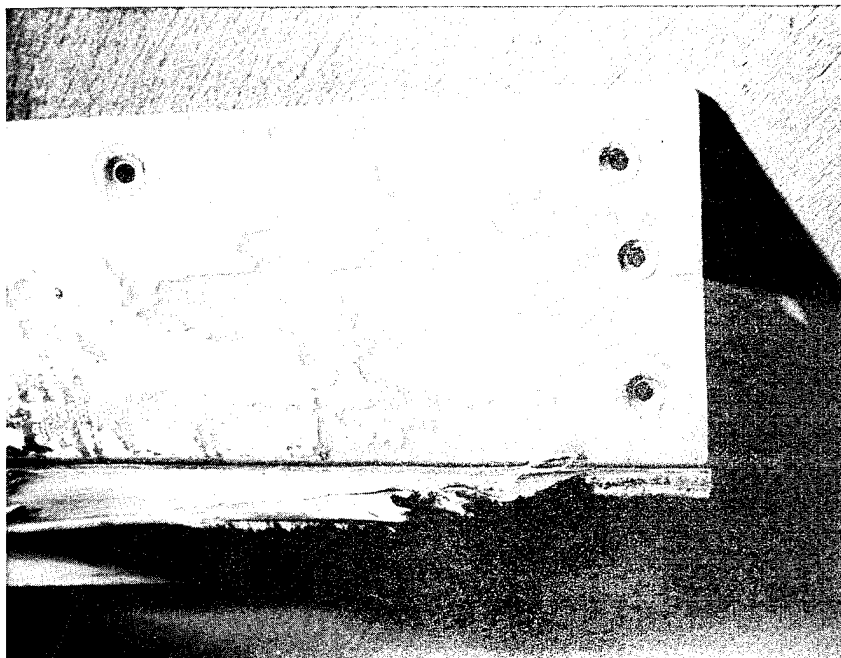
Figure 15. Eastern LH Underwing Fillet - Fastener Holes, Upper Aft Corner, from Exterior

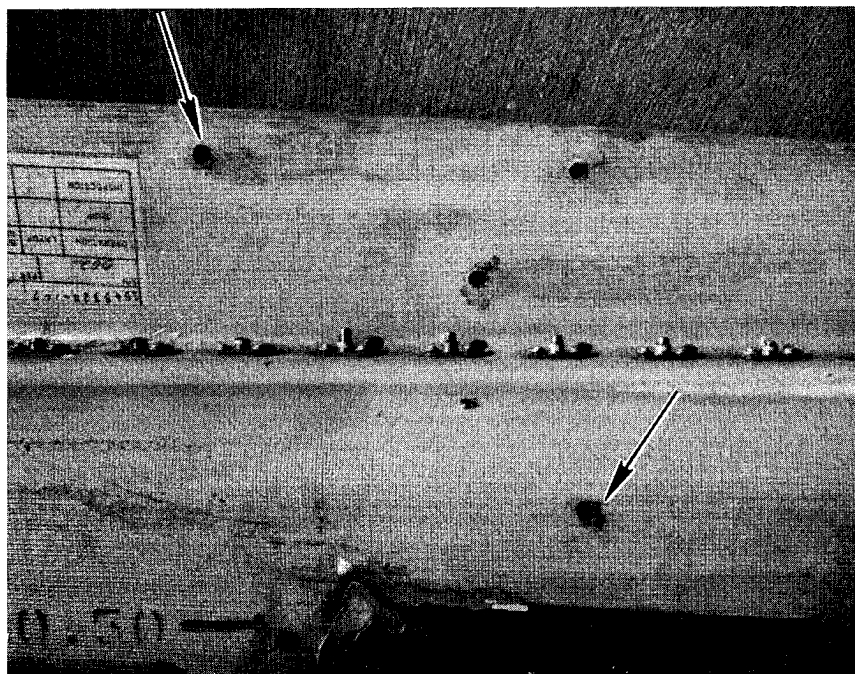
Figure 17. Eastern LH Underwing Fillet - Frayed Fastener Holes from Inner Surface

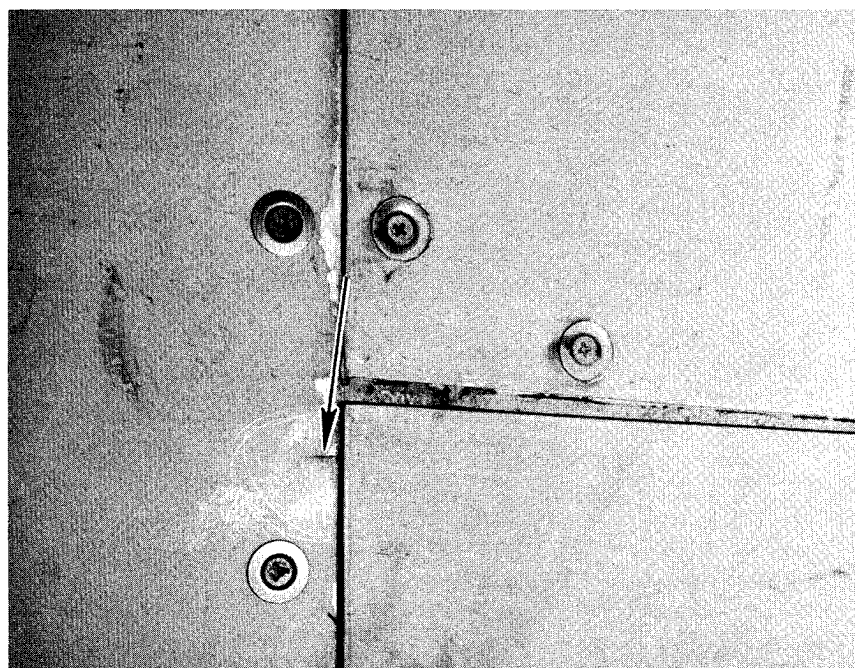
- 1) The following cracks observed in previous inspections were unchanged in appearance or extent:
 - 1.3 cm. (1/2 in.) crack at forward edge between 5th and 6th holes. No associated delamination. (Figure 18)
 - 0.6 cm. (1/4 in.) crack near exact center (may or may not be into skin) with scratch through paint to flame spray extending upward 20.3 cm. (8 in.). No delamination.
 - 0.3 cm. (1/8 in.) ding lower center - definitely into skin. No delamination.
 - 0.8 cm. (5/16 in.) crack in lower forward area - with slight associated delamination. 1.6 cm. (5/8 in.)
 - 0.3 cm. (1/8 in.) crack aft center - no associated delamination.

Figure 18. Eastern RH Wing-Body Fairing - Crack in Forward Edge 0.3 cm. (1/8 in.) Length

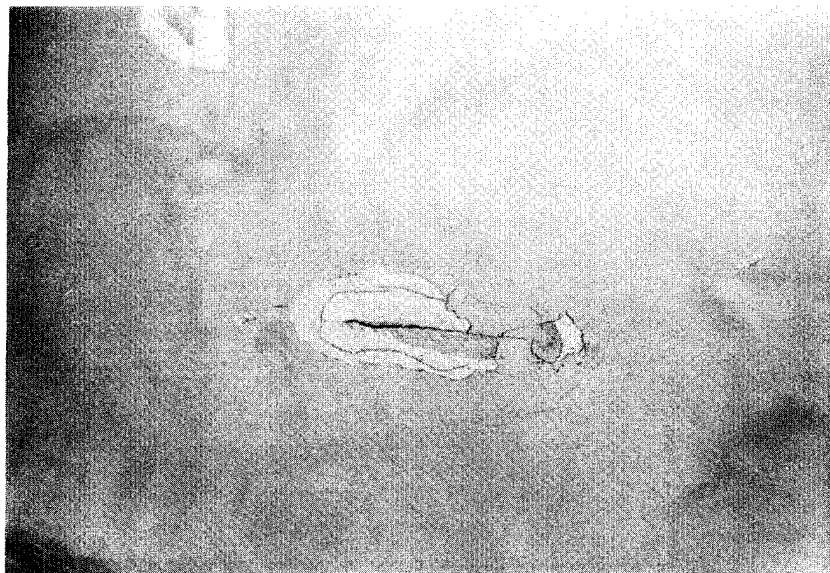
- 1) The panel weight was 697 kg (15 3/8 lbs.). Previous panel weight measured in 1976 was 672 kg (14.81 lbs.).
- 2) A 3.2 cm. (1 1/4 in.) crack was noted in the upper, aft area. (Figure 19). This crack has not grown or delaminated further since it was first observed in 1975. No other cracks were observed, and a 1.3 cm. (1/2 in.) crack observed in 1976 was apparently only in the original paint layer and had been repainted.

Figure 19. Air Canada LH Wing-Body Fairing - Crack, Exterior Surface, 3.2 cm (1-1/4 in.) Length

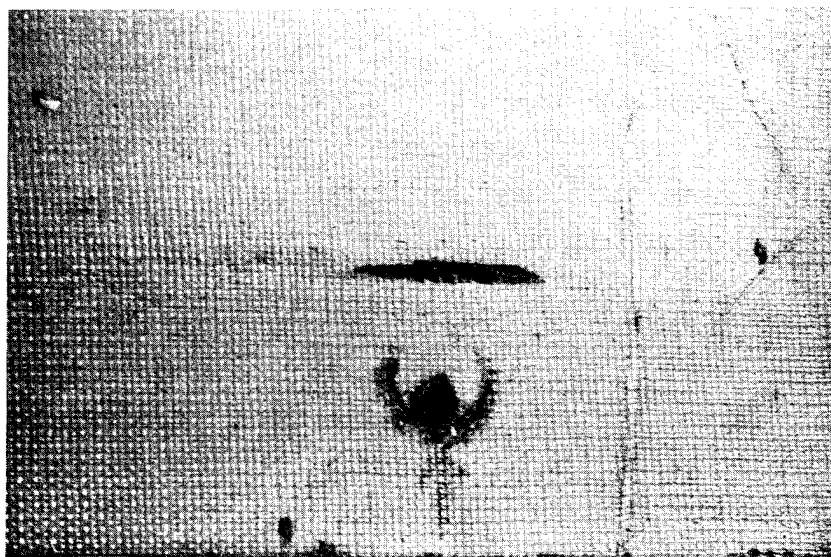
- 3) Fastener holes appeared slightly frayed as viewed from exterior and inner surfaces, with a greater degree of fraying noted on the bottom edge holes as viewed from the inner surface. (Figure 20). Slight hole elongation was observed on all fastener holes on the bottom edge, plus two other holes on the forward and top edges.

Figure 20. Air Canada LH Wing-Body Fairing - Close-Up of Fastener Holes on Bottom Edge, Inner Surface

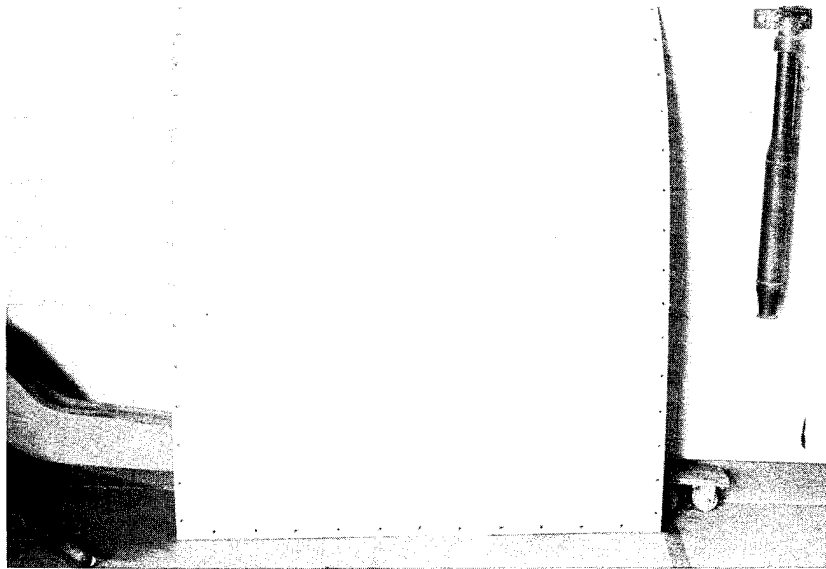
- 4) Extensive paint loss was observed on edges and upper forward area, but no associated damage in the part. (Figure 21).
- 5) No defects or damage were observed on the inner surface.

Figure 21. Air Canada LH Wing-Body Fairing - Exterior

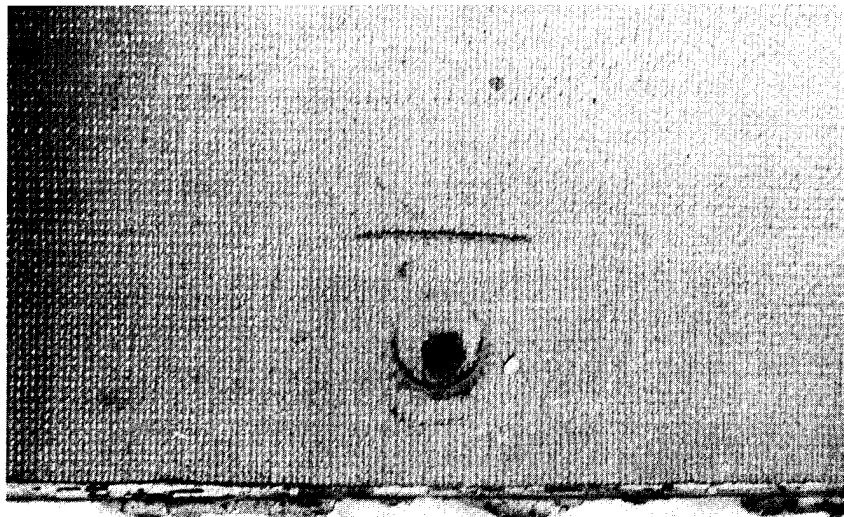
- 4) Slight fraying of fastener holes was observed on the upper, aft, and forward edges as viewed from either surface. A greater degree of fraying was observed on the bottom edge fastener holes. Several fastener holes were elongated to a slight degree on the bottom and aft edge. (Figure 23). One hole in the lower, forward, corner was elongated to 1.1 cm (7/16 in.) maximum dimension from the original 0.5 cm (3/16 in.) diameter. All lower edge holes had a slight convex deformation of the laminates around them with markings from the fastener heads.

Figure 23. Air Canada RH Wing-Body Fairing - Close-Up of Fastener Holes, Bottom Edge, from Inner Surface

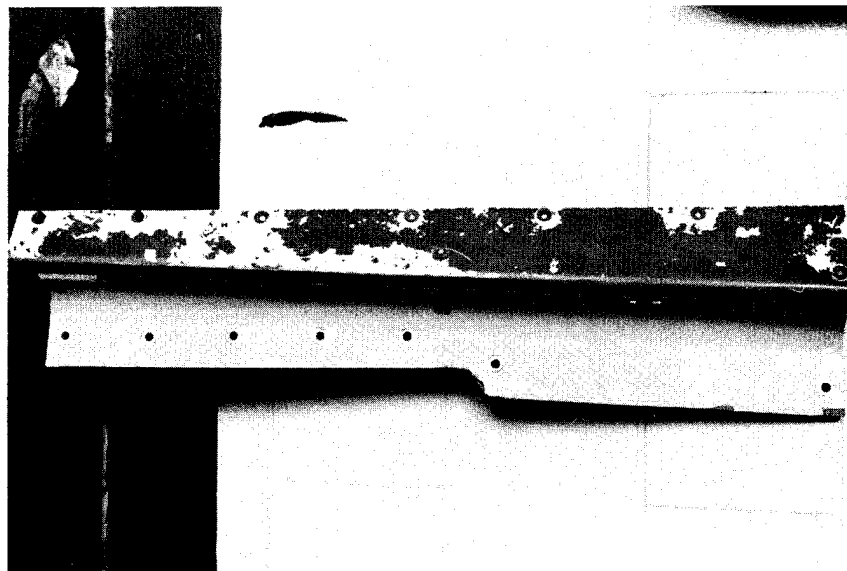
Figure 24. Air Canada LH Underwing Fillet - Exterior Surface

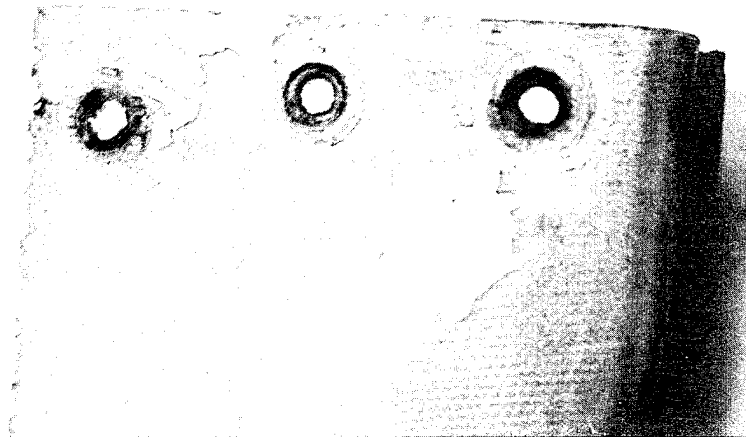
Figure 25. Air Canada LH Underwing Fillet - Fastener Holes, Upper Aft Area, from Exterior

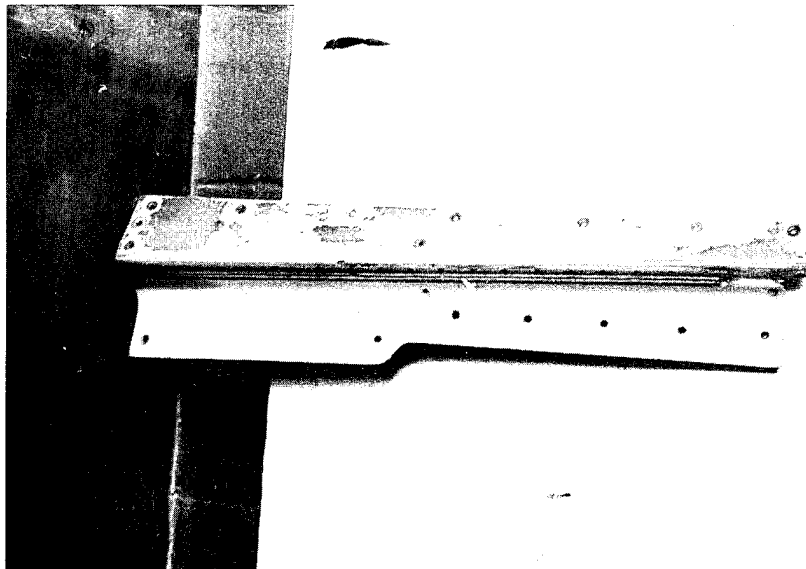
Figure 26. Air Canada RH Underwing Fillet - Exterior Surface

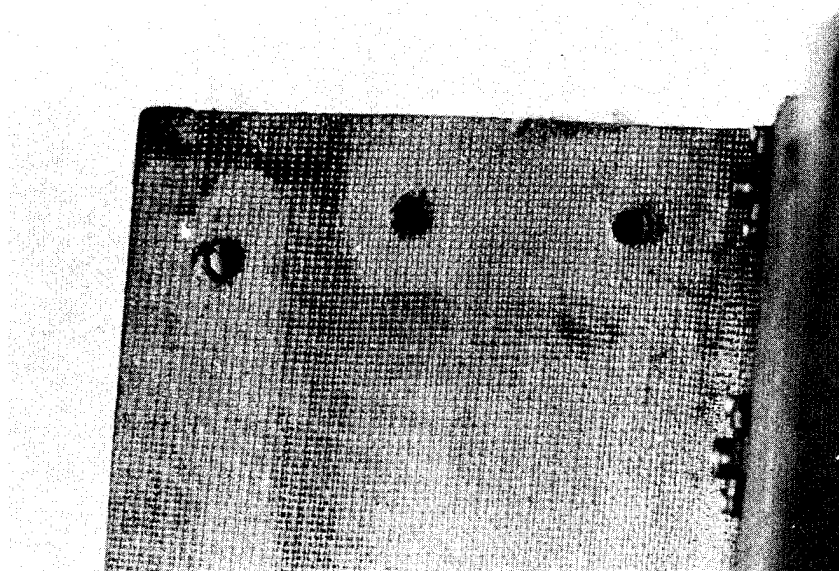
Figure 27. Air Canada RH Underwing Fillet - Fastener Holes, Upper Aft Area, from Inner Surface

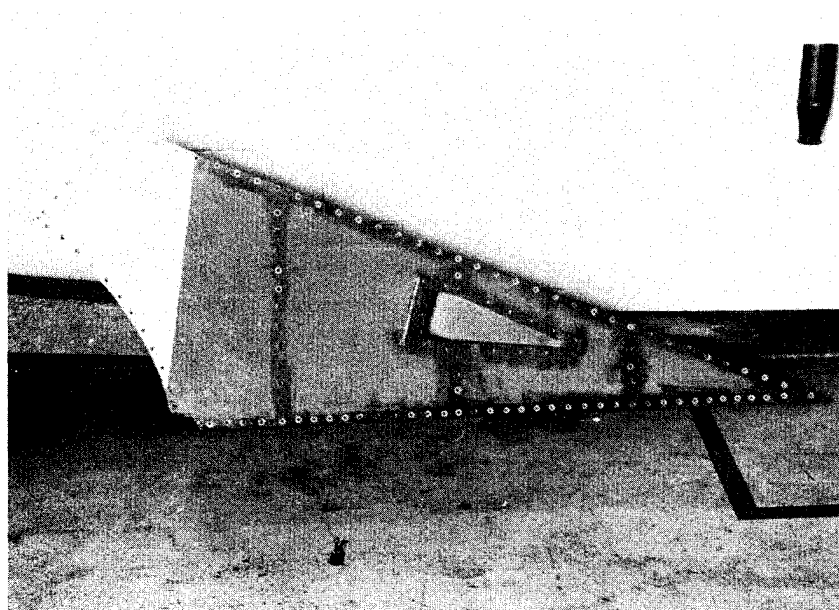
- 1) The panel weight was 2.89 kg (6 3/8 lb.).
- 2) No surface damage or defects were noted. (Figure 28).
- 3) Extensive fraying of fastener holes was observed on all edges as viewed from both surfaces. (Figure 29). Loose Kevlar-49 fibers were noted inside holes. The intercostal holes through the core area were more frayed than holes in the edge laminate. (Figure 30). Elongation was noted only to a very slight degree on three holes along the bottom edge.

Figure 28. Air Canada LH Aft Engine Fairing - Exterior Surface

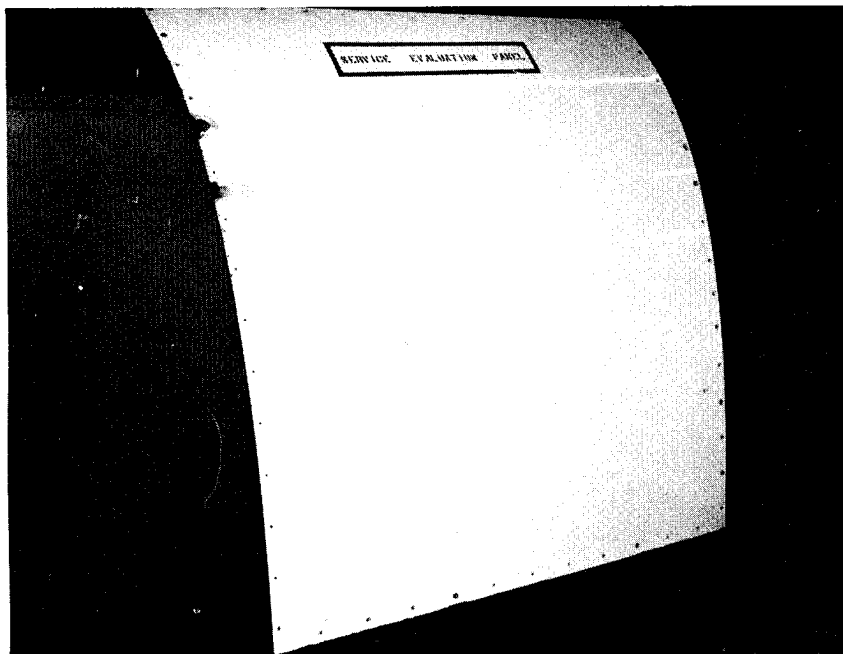
Figure 31. TWA LH Wing-Body Fairing - Exterior Surface

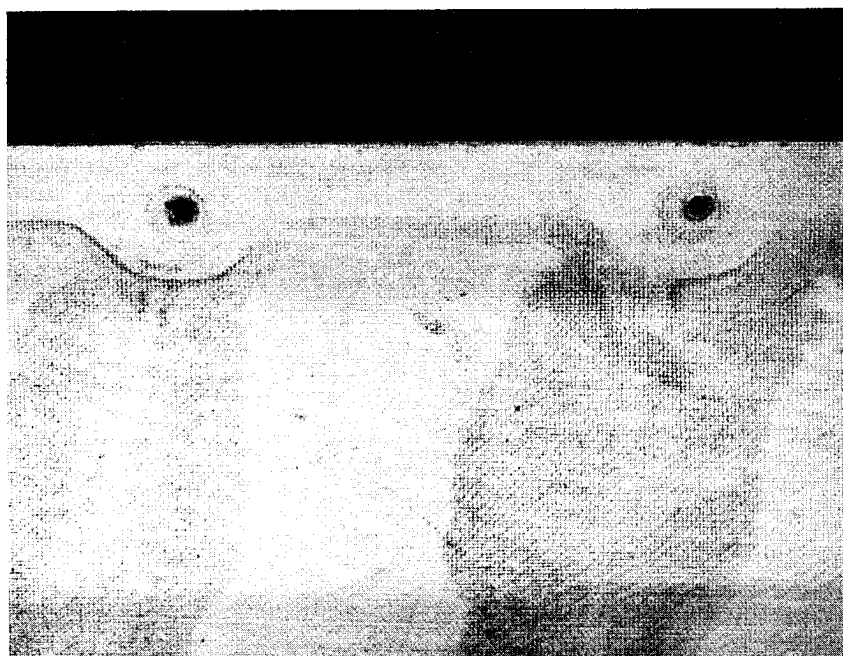
Figure 32. TWA LH Wing-Body Fairing - Typical Fastener Holes Viewed from Inner Surface

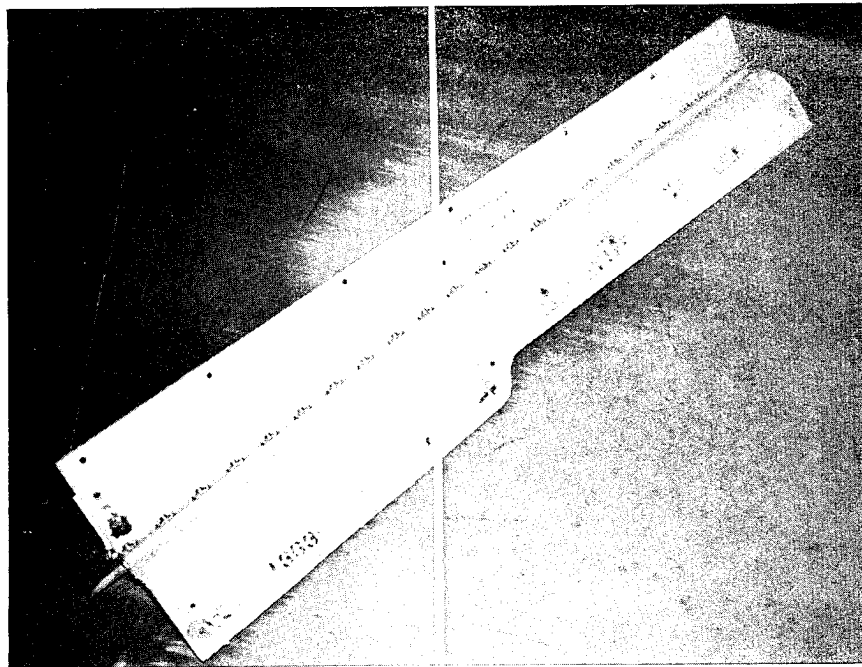
Figure 33. TWA LH Underwing Fillet - Inner Surface

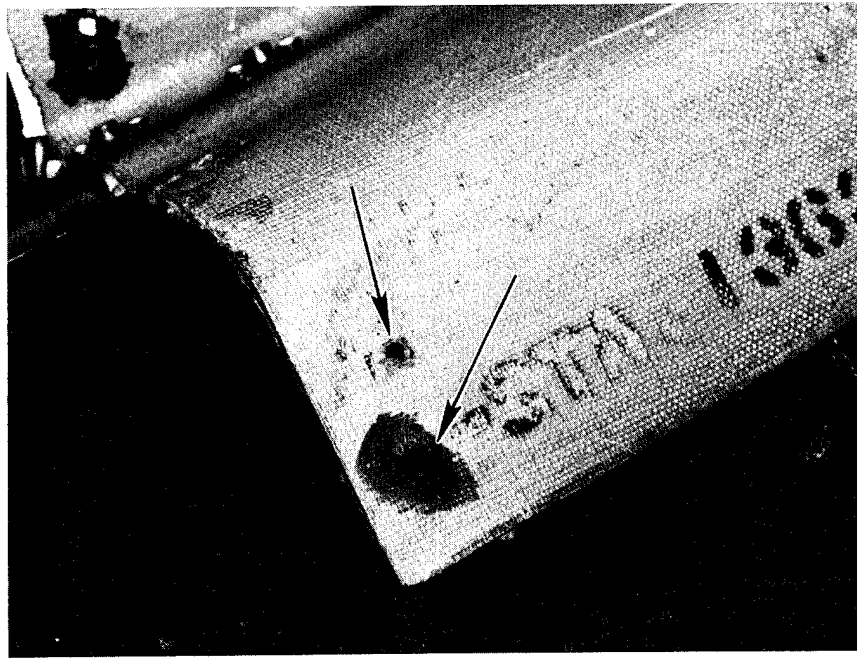
Figure 35. TWA LH Underwing Fillet - Filled and Relocated Fastener Holes

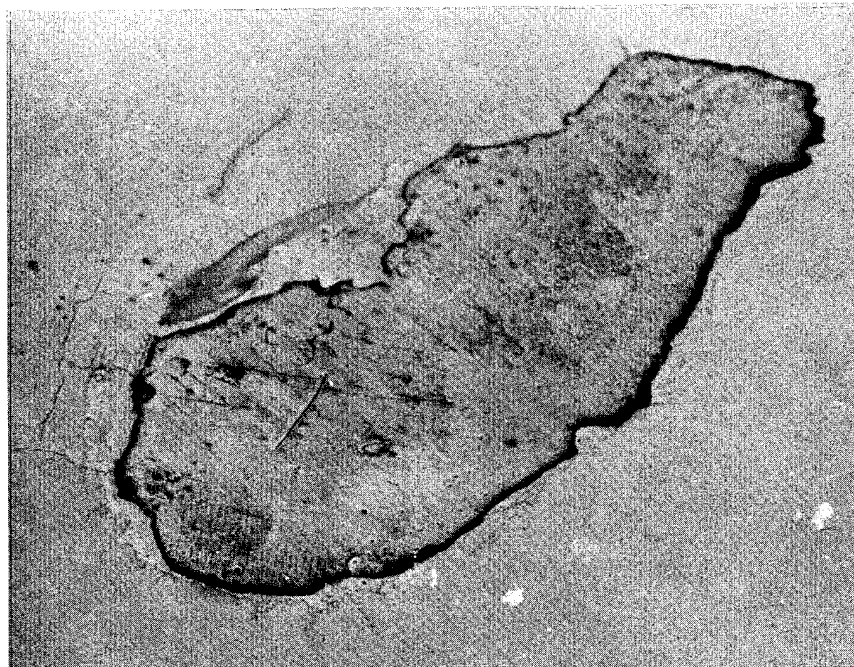
Figure 36. TWA RH Aft Engine Fairing - Repainted Area with Possible Skin Damage

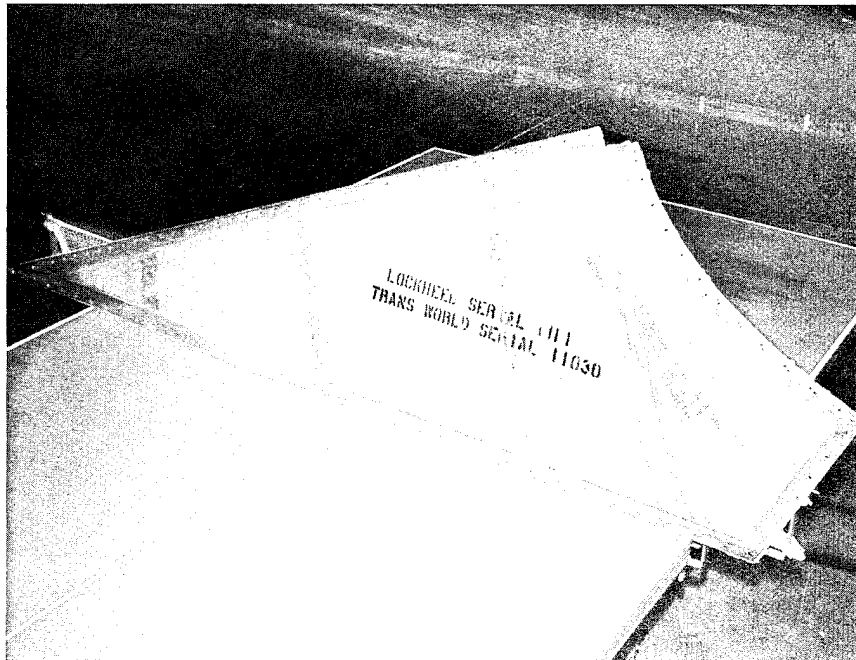
Figure 37. TWA RH Aft Engine Fairing - Inner Surface with Vapor Barrier Coating

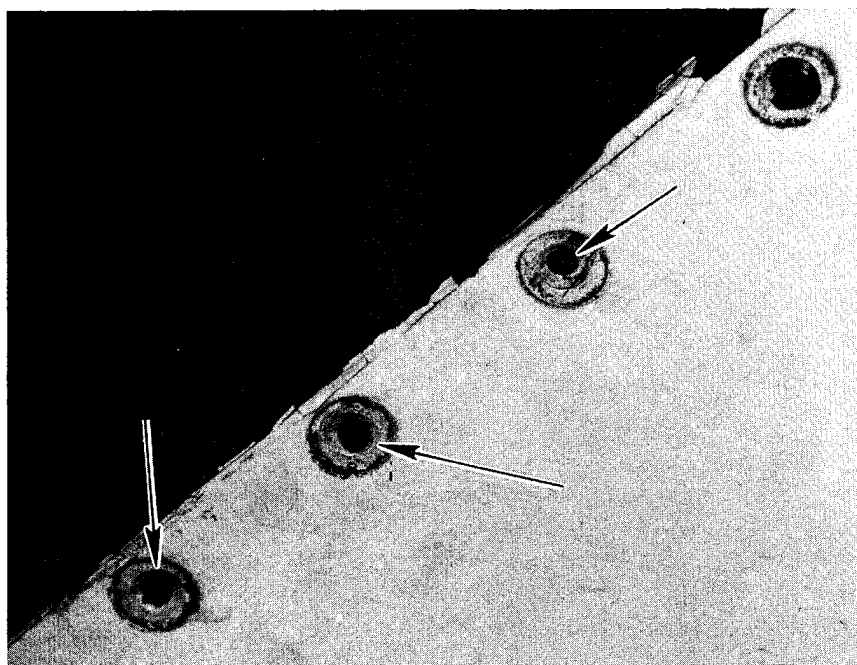
In one instance, hole deformation has been observed on parts other than the underwing fillets, and these are the TWA aft engine fairings. These fairings, as described in the Second Annual Report (Ref. 3), required relocation of all fastener holes during reinstallation. The holes were filled with a chopped glass filled epoxy, and a layer of epoxy impregnated 120 glass cloth was applied to both surfaces. Many holes were redrilled through the filled area, and these holes show a significantly greater degree of elongation than any holes drilled through a solid Kevlar-49 laminate. This condition, while not affecting part performance or requiring corrective maintenance, does indicate an inadequacy of the repair; and does not reflect on the performance of Kevlar-49.

Figure 39. TWA RH Aft Engine Fairing - Fastener Holes Viewed from Exterior, Showing Elongation

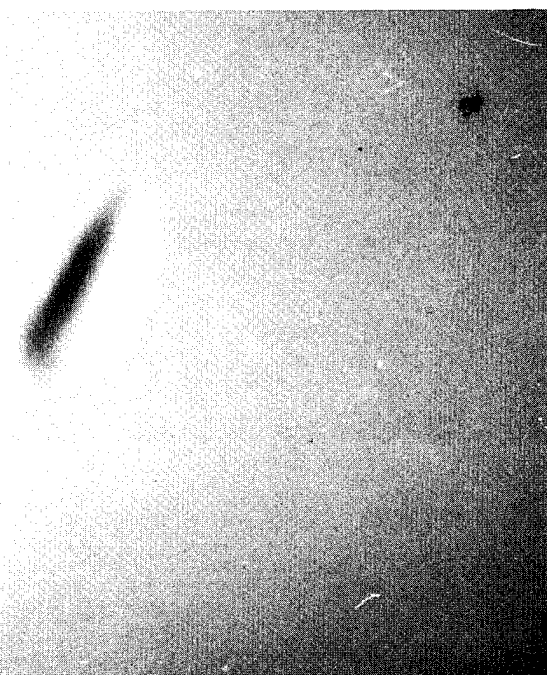
A more extensive damage condition was observed on the TWA right-hand wing-body fairing. This is a fairly deep concave depression and skin-core disbond, but with no associated crack or surface damage, which does not appear to be the result of impact damage. This condition is probably related to a repair made in this part during its reinstallation on Ship 1111 (Ref. 3). This repair was not documented, but apparently consisted of replacement of a damaged core area, extending partially through the core thickness, with a microballoon filled potting compound. Crushing of this potting compound under in-service conditions is a possible explanation of this condition. In any case, this does not appear to be a Kevlar-49 related problem, but as it is highly visible it will be carefully monitored in future inspections.

Figure 40. TWA RH Wing-Body Fairing - Concave Depression with Disbond, Exterior Surface

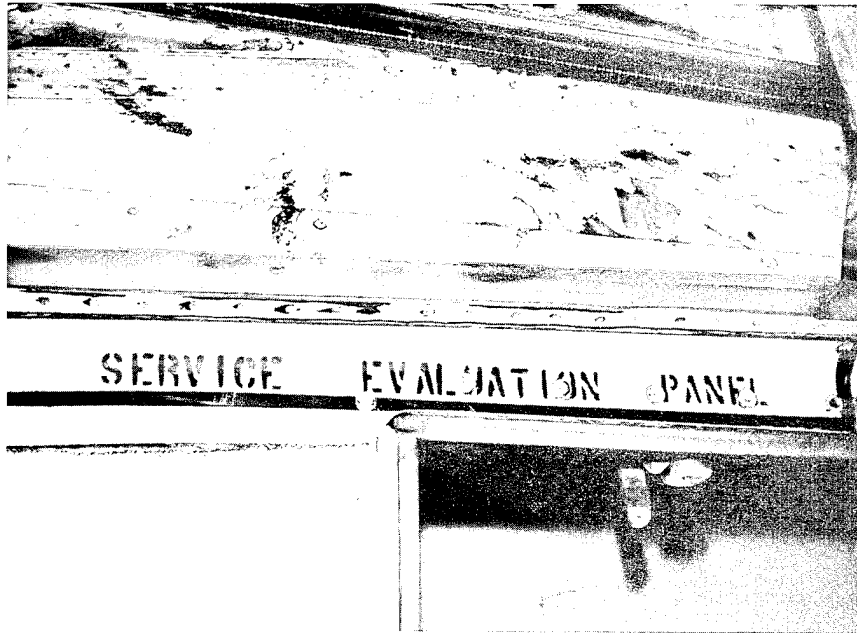
Figure 41. TWA RH Underwing Fillet - Exterior Surface on Aircraft

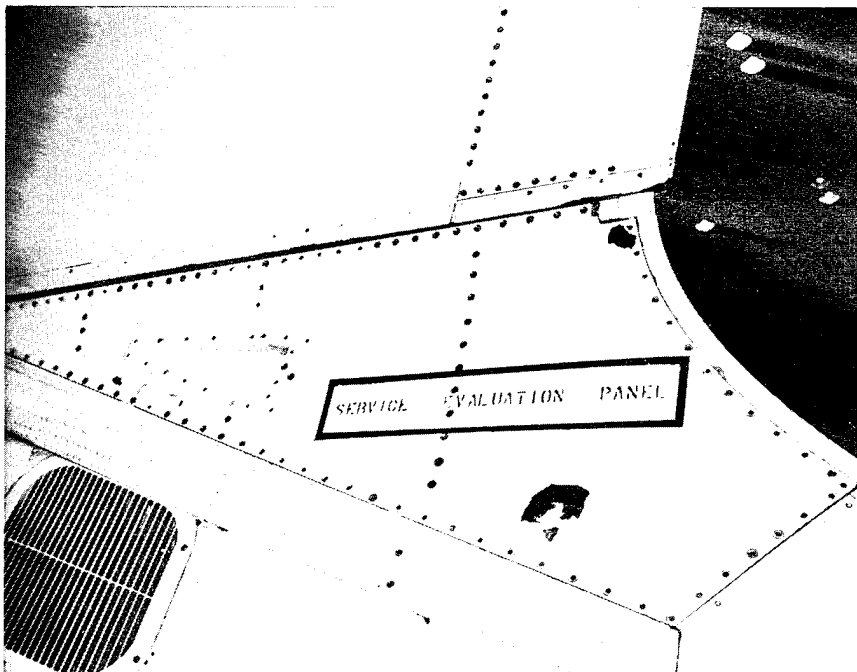
- 1) No disbonds were detected. However only the lower aft area could be reached for coin tapping. No damage or defects were visible. No fastener misalignment was visible.
- 2) An area of paint loss and Flame spray loss had increased since the 1976 inspection, and Kevlar-49 surface was exposed to UV. (Figure 42). The exposed areas showed no signs of discoloration or other damage. Some of the exposed Kevlar-49 areas had been repainted.

Figure 42. TWA LH Aft Engine Fairing - Exterior Surface on Aircraft Showing Paint Loss Areas
